# Platypus News & Views

*Newsletter of the Australian Platypus Conservancy (Issue 92 – August 2023)*

## IN-STREAM BARRIERS AND THE PLATYPUS

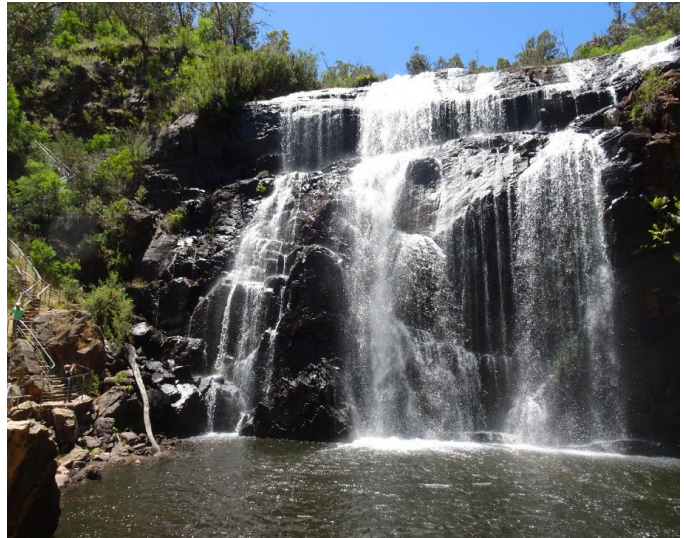
Given that platypus populations have had to cope with natural in-stream barriers for millions of years, it's not surprising that these animals will sometimes leave the water to do so. For example, two adult males marked with microchip tags in studies commissioned by the Wimmera CMA in western Victoria have been captured at sites above and below Mackenzie Falls (shown at right). These falls rise more than 30 metres and are undoubtedly too steep to be scaled directly by a platypus. However, the neighbouring slope as seen in the photo should provide quite a straightforward path for a platypus to scramble past the barrier.

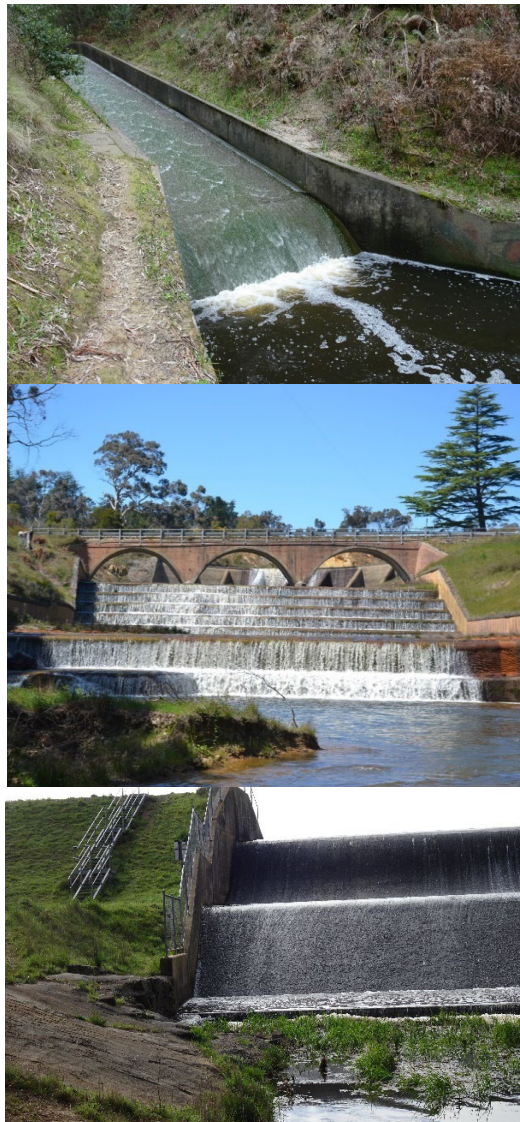
In some cases (for example, the steeply sloping section of spillway channel shown at top right), consideration could be given to assisting animals seeking to move upstream by scoring horizontal grooves across the slope to improve traction. This should also promote safer and easier travel by a platypus walking downstream along the spillway when the channel is dry.

In cases where one or more vertical steps occur along a spillway channel (as shown at middle right), one potential way to assist longitudinal travel would be to add appropriately engineered ramped surfaces within the spillway so a platypus can ascend or descend each step. Alternatively, it may be possible to create a route for a platypus to climb out of the spillway and access the adjoining vegetated slope in order to bypass the steps entirely.

In yet other cases where a reasonably easy route may already exist for a platypus to exit the channel and bypass a barrier (as shown at bottom right), associated predation risk can potentially be reduced by ensuring that plenty of protective cover is available in the form of low-to-medium shrubs, sizable grass tussocks, strategically placed logs, etc. To provide genuine benefit to a dispersing platypus while not unduly compromising human access, these materials may best be placed in a strategic fashion along the outer edge of the spillway, starting near the point where a platypus is most likely to leave the water.

In many cases, the key underlying issue is that the platypus is a short-legged animal that is physically unable to climb a step rising more than about 20 cm – and quite possibly even less in the case of small dispersing juveniles. Vertical surfaces are an even more intractable barrier when a platypus is in the water, given that it cannot reach up to any significant extent while swimming.
